P1094

Mass air flow in front of throttle implausible

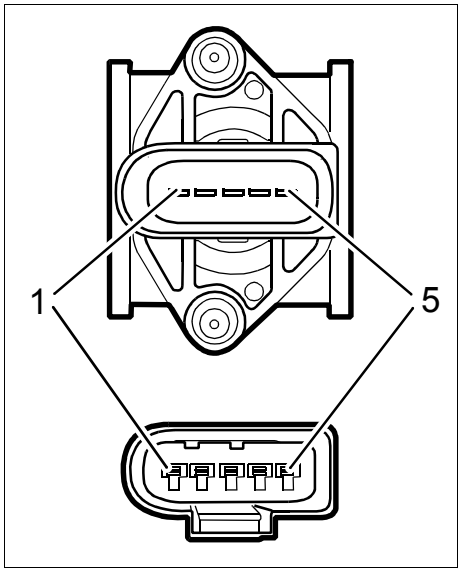
Hot film mass air flow meter ►

- Throttle stiff or 'blocked'
- Secondary air between hot film mass air flow meter and throttle (e.g. crack in hose)
- Throttle adjusting unit faulty
- Hot film mass air flow meter faulty (intake air temperature sensor)
- Hot film mass air flow meter faulty
- DME faulty (pressure sensor for ambient air pressure)

- *In this fault code, the intake system between the hot film mass air flow meter and the throttle is monitored.*
- *The pressure sensor for the ambient air pressure is installed in the engine control module.*

Work instruction			Display OK	If not OK
1	Check actual values	♦ Using the 9588 Porsche System Tester II, read out the 'RKAT' and 'FRAU' adaptation values under "Actual values" and evaluate the difference	The adaptations are well below the unadapted value ⇒ Step 2 The adaptations are well above the unadapted value ⇒ Step 4 The adaptation values are OK ⇒ Step 6	
2	The adaptations are well below the unadapted value	♦ Check air guide between hot film mass air flow meter and throttle for leaks	⇒ Step 3	Continue troubleshooting in Workshop Manual ⇒ Group 2; Rep. Gr. 24; Fuel system, electronic injection → End
3		Check operation of hot film mass air flow meter ♦ Switch on ignition ♦ Switch off all 'loads' ♦ Measure signal voltage between DME control module plug A, pin 29, and ground ♦ Switch off ignition	0.9 V to 1.1 V ⇒ Step 9	Replace faulty hot film mass air flow meter → End

Work instruction			Display OK	If not OK
4	The adaptations are well above the unadapted value	Check operation of hot film mass air flow meter ♦ Switch on ignition ♦ Switch off all 'loads' ♦ Measure signal voltage between DME control module plug A, pin 29, and ground ♦ Switch off ignition	0.9 V to 1.1 V ⇒ Step 5	Replace faulty hot film mass air flow meter → End
5		♦ Check fuel system for correct fuel pressure and mechanically faulty injection valves	Continue troubleshooting in Workshop Manual ⇒ Group 2; Rep. Gr. 20; Checking fuel pressure and quantity delivered → End	
6a	Adaptation values are OK	♦ Check throttle adjusting unit for stiffness in accordance with Workshop Manual ⇒ Group 2; Rep. Gr. 24; Fuel system, electronic injection	Throttle adjusting unit mechanically OK ⇒ Step 7	Mechanical faulty in throttle adjusting unit ⇒ Replace throttle adjusting unit → End
6b		♦ Check throttle adjusting unit for sticky soiling	Throttle adjusting unit OK ⇒ Step 7	Clean throttle adjusting unit and check engine for oil consumption; correct the cause of the fault if necessary → End

7		♦ Pull off plug from hot film mass air flow meter ♦ Visual inspection ♦ Measure resistance between pins 1 and 3 of hot film mass air flow meter	2,250 Ω to 2,560 Ω at 20°C ⇒ Step 8	Intake air temperature sensor faulty → End
8		Check ambient pressure sensor ♦ Using the 9588 Porsche System Tester II, read out the actual value of the ambient pressure sensor ♦ Compare the value that has been read out with the display value of a calibrated barometer	The values roughly agree → End	Difference between the values of the ambient pressure sensor and those of the barometer are too great ⇒ Step 9

Work instruction		Display OK	If not OK
9	Check whether additional faults are entered	⇒ Step 10	Work through faults in accordance with instructions → End
10	Replace DME control module	Observe the notes on possible causes of faults in the introduction at all times!
